PERFORMANCE AUDIT REPORT ON THE SOMALIA CRISIS RECOVERY PROJECT

August 2024

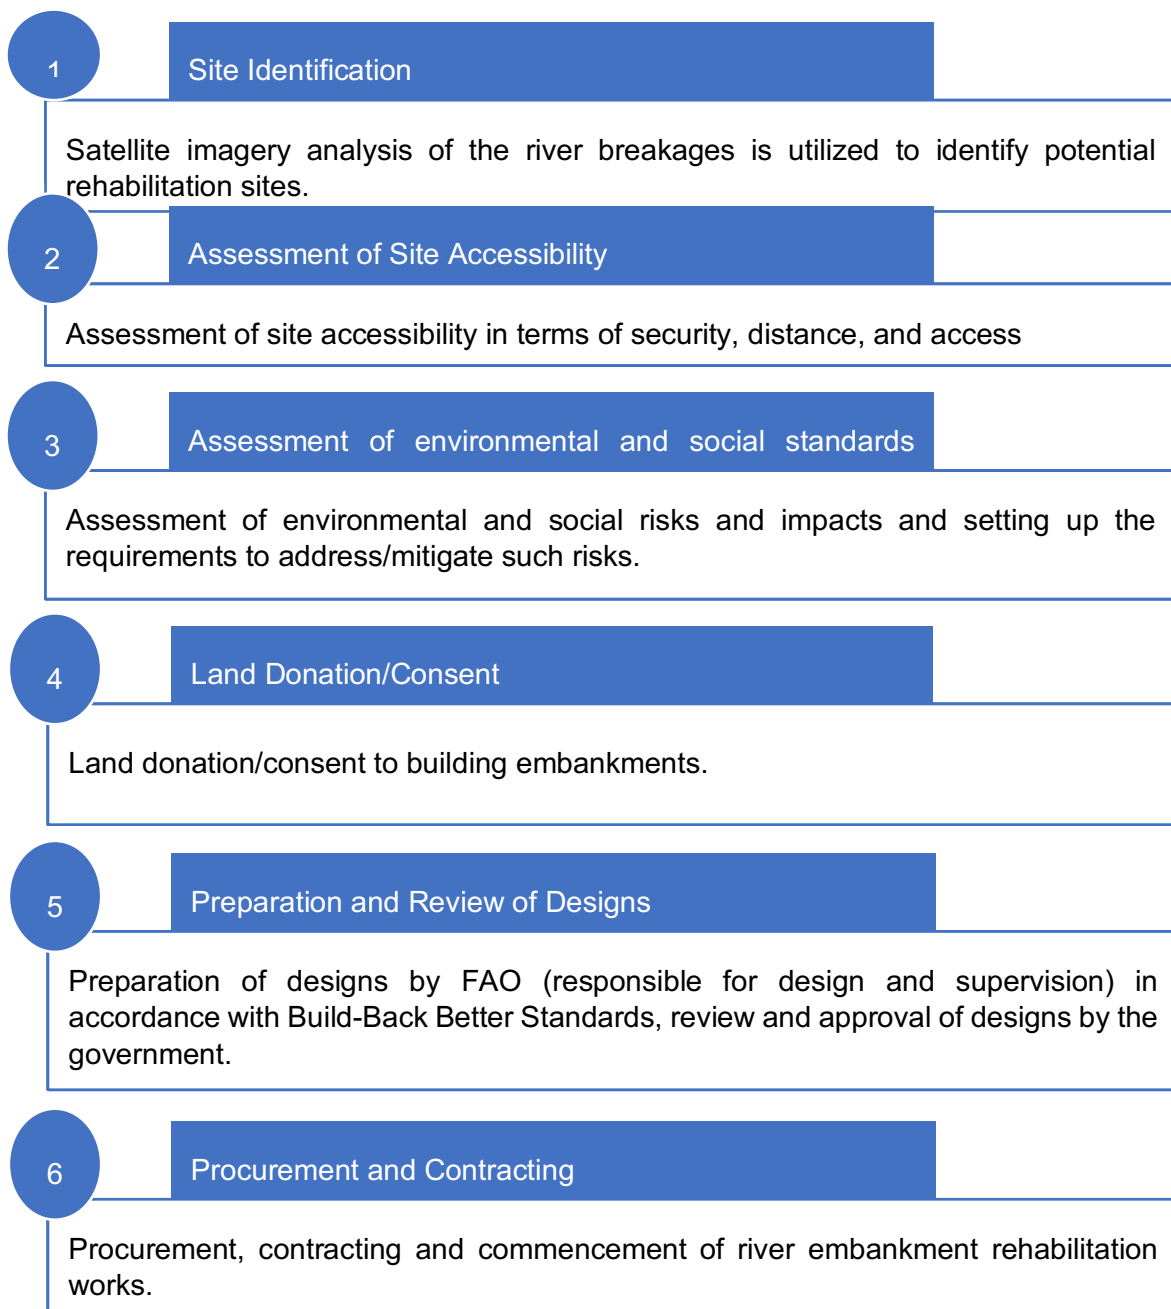
Figure: River embankment works process description

The processes involved in the rehabilitation of river embankments are indicated in the figure below:

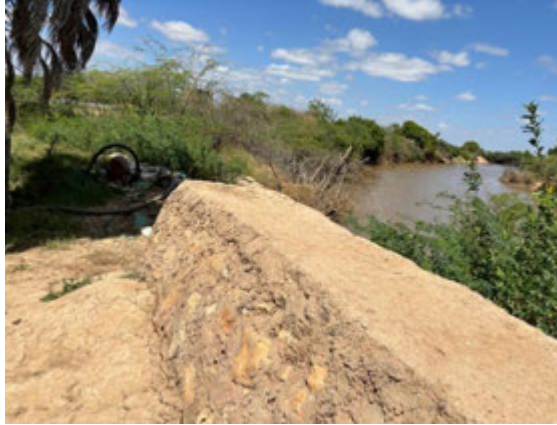
Moreover, the audit team observed gaps in and at the gaps at the end of Sigalow/Yusuf A and Hawatako 4 sites in Beledweyn. This caused a passage for the flooding that affected farmland and surrounding areas.

Sigalow – Yusuf A site in Beledweyn: A gap at the end of masonry wall

We recommend that the PIU should address these gaps, and place a high priority on comprehensive community engagement, should consider community needs and concerns, the advice of site assessments conducted by site engineers.

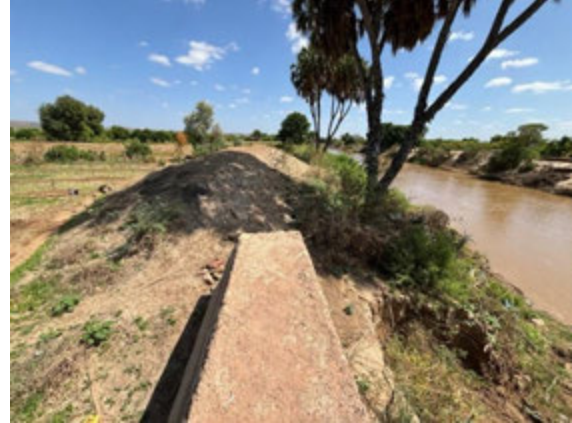
Hawatako 4 site in Beledweyn: A gap at the end of masonry wall

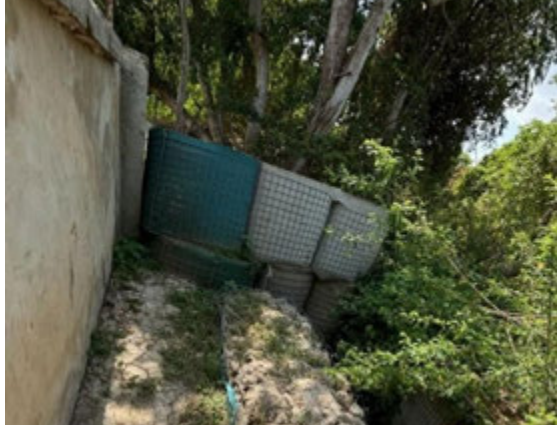
We found in the Imaraat 2 site in Afgoye district an incomplete gabion wall as the contractor did not extend the gabion wall at the end of the site as per the required specifications. Instead, the contractor used sandbags to fill the gap created due to the farm owners' request for a separate wall. According to PIU engineer, the gap at this site was a result of challenges to securing farmer's consent. Therefore, this incomplete wall compromised the effectiveness of the river embankment, allowing water to leak through and causing erosion of the soil behind the wall. Additionally, the irrigation chamber designed to facilitate farmers' access to river water at this site caused water to overflow during the last rainy season. The resulting overflow led to dissatisfaction among the farm owners where the chamber was located, prompting them to close the water inlet with a concrete seal.

Sandbags are used at the end of the gabion wall in Imarat 2 site in Afgoye to fill a gap

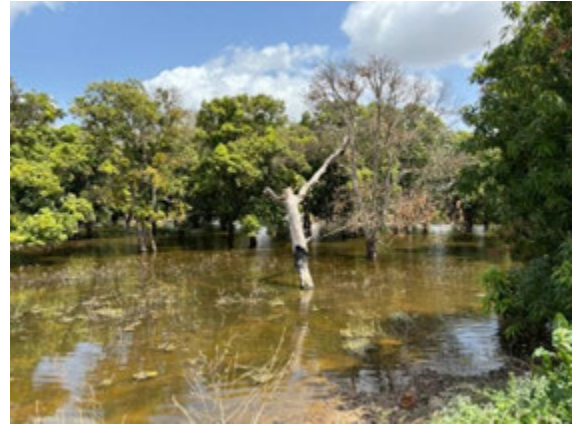
Swamped farmland destroying fruit producing trees in Kuweyt 1 site in Afgoye

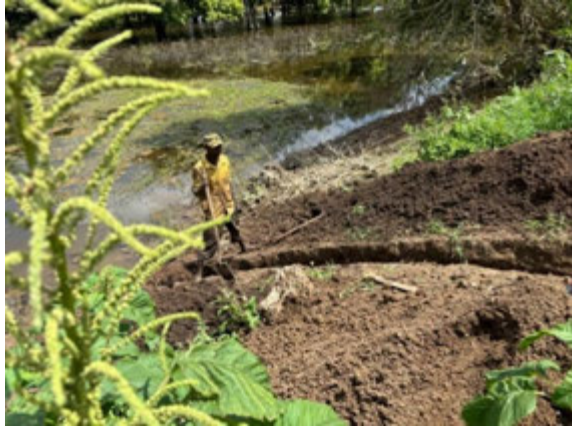
During site visits, we observed that the Kuweyt 1 and Aytiro 1 sites in Afgoye district lacked drainage or water inlet/outlet. The lack of a drainage mechanism indicated a significant planning issue that was overlooked.

The inefficient water flow management due to the lack of proper planning and implementation of a drainage system has led to several issues. Rainwater gets trapped in the farmland, causing water to encroach on the foundation of the gabion wall, which leads to leakages. Additionally, farmers have resorted to tearing and damaging the wall, which could potentially harm the effectiveness of the constructed river embankment. This embankment is meant to allow trapped water to escape to prevent the farmland from turning into swamps, thus protecting the fruit-producing trees in the farms.

Kuweyt 1 site as farmer trying to tear the gabion wall to let the water out

We recommend that the PIU conducts a comprehensive review of the planning and construction processes for riverbank protection works. This review should ensure the inclusion of essential drainage systems in current and all future projects to optimize water management and safeguard the integrity of constructed infrastructure.

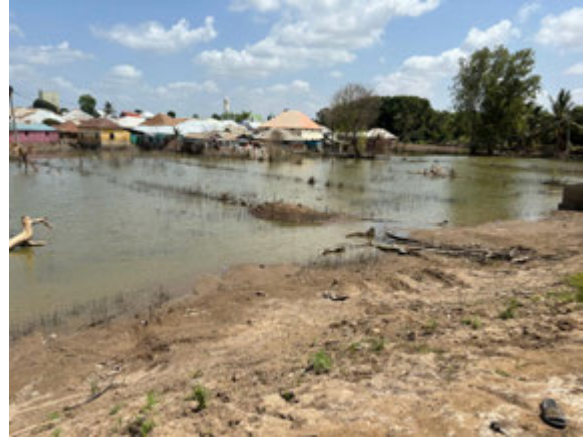
Stormwater getting trapped in the farmland at the Aytiro 1 site in Afgoye

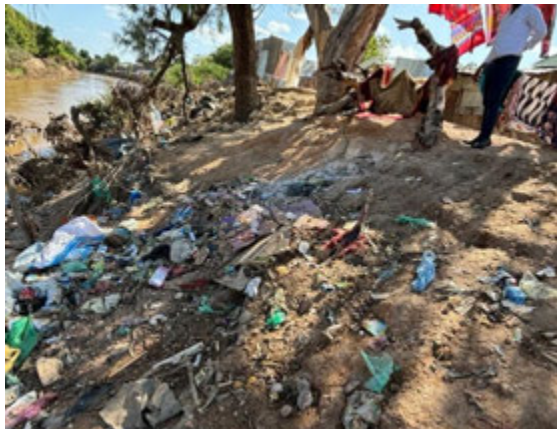
Picture Grid 5: Example of defected river embankment site at Hawatako – Kawanka in Beledweyne town

We assessed PIU’s implementation of their planned activities to complete river embankment rehabilitation works in terms of the protection it provided and the quality of final outputs. Our site inspection in Hawatako – Bundada Kawanka site in the Baladweyne town, revealed significant quality defects: missing embankment and breakage backfilling, absence of required stone pitching, missing stone pitching at the toe, and riverbank collapse and damage.

The riverbank in Hawatako – Kawanka has completely collapsed, causing trees and parts of a house to be swept into the river.

We recommend that urgent corrective actions be taken by PIU on all the affected sites to rebuild collapsed sections, and repair washed-away portions, to enhance the effectiveness of the embankment and make them sustainable.

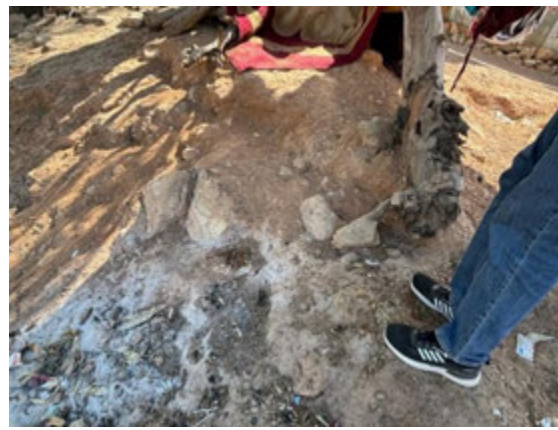
Traces of the stone pitching for the soil embankment is seen as most of it slid into the river

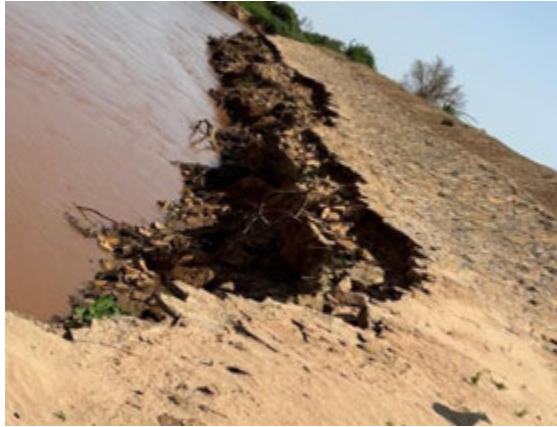
During site visits in Sulgudud/Nasteh, Sulgudud/1, 2, 3, and Sulgudud/Hussein Ibrahim, we found defects at the edges of the site caused by floods. This shows that the rehabilitation works implemented have limited sustainability. Field engineers indicated that gabion walls are more reliable than soil embankments and require less space.

A portion of the stone pitching is washed away by floods in Sulgudud 1 site Dolow

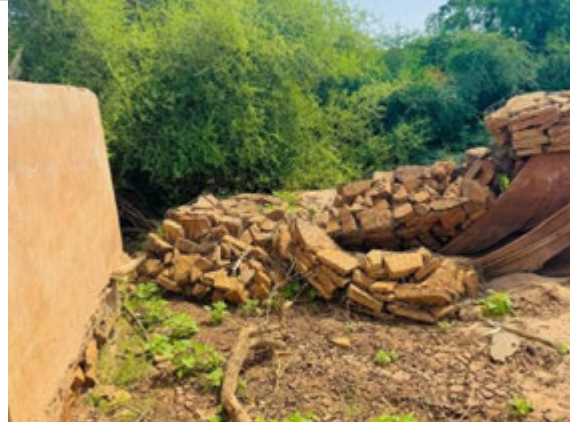
A portion of the gabion wall is collapsed Sulgudud/Hussein site Dolow
