**OFFICE OF
THE AUDITOR GENERAL**
OF THE FEDERAL REPUBLIC OF SOMALIA

PERFORMANCE AUDIT REPORT ON THE WATER FOR AGRO-PASTORAL PRODUCTIVITY AND RESILIENCE, THE BIYOOLE PROJECT

August 2024

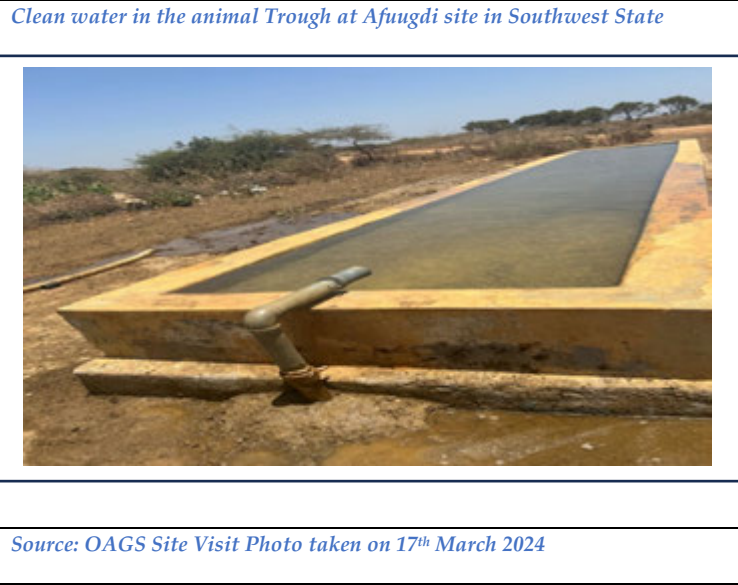
During the inspection, the audit team discovered that a borehole that was initially constructed in 1991 had been rehabilitated to restore its functionality at Afuugdi site in Southwest State. It was observed that the borehole was functioning effectively, providing high-quality water suitable for domestic and other purposes. An efficient water pumping system was in place, ensuring the smooth operation of the borehole. A kiosk with 6 taps had been constructed for the community and was actively being used. Animal water troughs, designed according to the Bill of Quantities (BOQ), were built for camels, cattle, goats, and sheep. These troughs were being utilized as intended. The condition of the watchman's house was verified to be good. A power generator, including a photovoltaic (PV) system, was present and actively in use to support water flow effectively.

Following the successful rehabilitation of the borehole observed in Afuugdi village, Baidoa district at Southwest State of Somalia, it is advised that the project implementing unit consistently meets its responsibilities with the same diligence for similar activities in the future, thereby serving the interests and the wellbeing of the vulnerable citizens effectively.

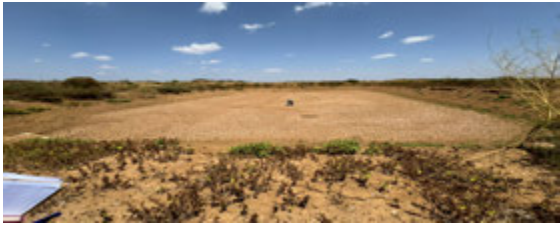
<i>Source: OAGS site visit photo taken on 17th March 2024</i>	<i>Source: OAGS site visit photo taken on 17th March 2024</i>

4.2.1 Despite a substantial investment of **\$140,500.53** in the construction of a water catchment at **Warmakiinaay site in Southwest State**, severe shortcomings in the activities implemented were identified during the audit. The site inspection uncovered that the constructed dam was entirely non-functional and dry, failing to meet the essential requirements outlined in the Bill of Quantities (BOQ). The audit team found only one water channel built instead of the two required, and the dam’s embankment lacked the necessary hardcore filling. Additionally, the construction did not include the permanent trash screen and fence specified in the BOQ, and critical components such as the power generator (including PV system), water pumping equipment, and UV treatment were absent from the site even though the contractor was paid for these items. These deficiencies highlight a significant deviation from the approved plans and a significant waste of resources.

<i>Non-functional water catchment lacking surrounding fence and proper embankment</i>	<i>only one water channel without a permanent trash screen</i>

We recommend that the project coordination unit to take an action to address and rectify the deficiencies identified in the construction of the water catchments. To prevent future failures, we also recommend stringent quality control, robust project management, and community engagement for similar future activities. And the unit must prioritize the use of high-quality materials, skilled labour, and transparent financial management.

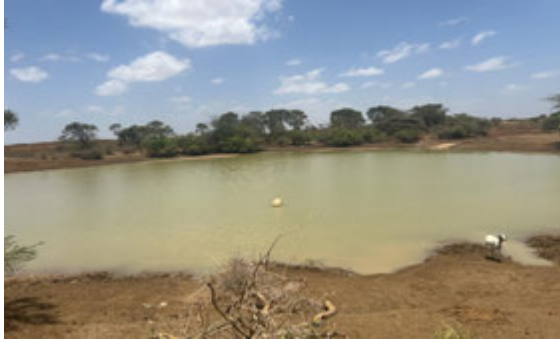
Source: OAGS site visit photo taken on 18 th March 2024	Source: OAGS site visit photo taken on 18 th March 2024

4.2.2 Even though material amount of **\$162,959.92** was spent in constructing the water point system at **Awdiinle1 site in Southwest State**, the audit revealed critical failures in project execution. The dam built was of substandard quality, failing to meet the specifications outlined in the Bill of Quantities (BOQ) for the restoration of Balley through excavation. The inspection found that the embankment was inadequately constructed with weak and improperly filled hardcore. Additionally, a significant portion of the fence was broken due to the use of poor-quality metallic materials, as physically observed and noted from the community members. The inflow water channel was ineffective, damaged, and lacked a proper foundation, while the overflow channel was never constructed. The power generator (including PV system) and solar panels delivered to the site were not installed, and the water pump was non-operational, this has compromised the flow of water into the tank and the overall effectiveness of the water system. Even though the payment to the contractor included

The constructed dam at Awdiinle I in South West State	Broken fence at the Dam at Awdiinle 1 in South West State

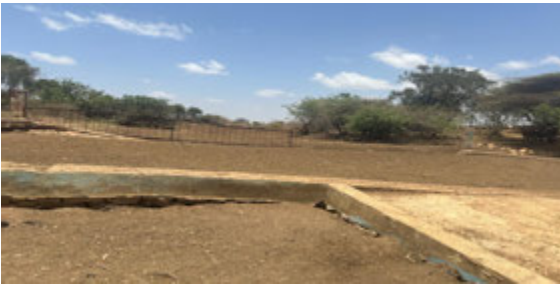
Source: OAGS site visit photo taken on 18 th March 2024	Source: OAGS site visit photo taken on 18 th March 2024

Ineffective water channel with poor foundation built at Awdiinle 1 Dam	Uninstalled solar panel found in store at the Awdiinle 1 Dam

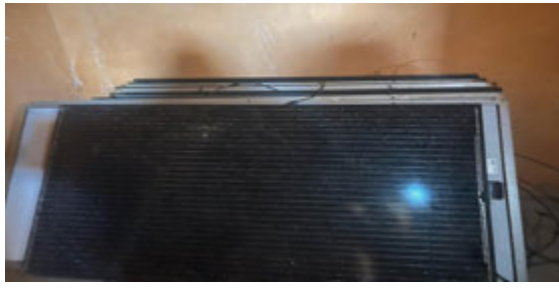
the cost for a water purification system, no UV treatment system was provided and installed to ensure water cleanliness and safety. Consequently, the water kiosks and animal troughs have remained unused, forcing both the community and livestock to use and drink unclean and unfiltered water directly from the dam.

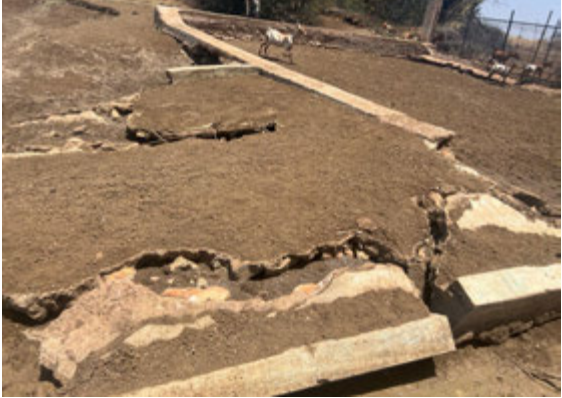
<p>Source: OAGS site visit photo taken on 18th March 2024</p>	<p>Source: OAGS site visit photo taken on 18th March 2024</p>

4.2.3 The constructed dam at Awdiinle 2 site in Southwest State with material costing **\$157,101.72**. However, during the audit the engagement team identified that numerous specific requirements outlined in the Bill of Quantities (BOQ) for the restoration of Balley by excavation were not fulfilled. Specifically, the fence surrounding the dam was incomplete and of poor quality and the embankment was also of poor quality as its foundation lacked the proper hardcore filling. The water channel foundation appeared weak and showed extreme damage, including severe cracks and this has resulted in blocking the intended water flow path way with debris such as soil, sand and stones. Another notable issue was the absence of UV treatment for water purification which led to the lack of clean and safe drinking water even

<p>Damaged and blocked water channel with poor foundation at Awdiinle 2</p>	<p>Awdiinle 2 dam with incomplete fence and improper embankment</p>

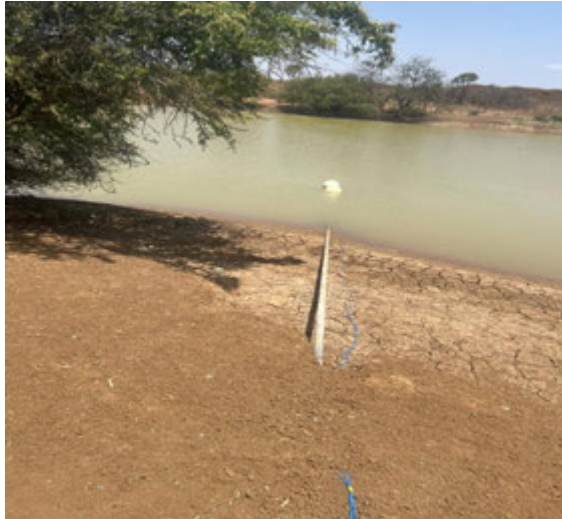
<p>Source: OAGS site visit photo taken on 18th March 2024</p>	<p>Source: OAGS site visit photo taken on 18th March 2024</p>

though the contractor was paid for the purification system. An issue with the water pump was discovered, the pipes used to transport and pump water were too short to reach the middle of the Dam, which slowed down the effectiveness of water flow into the tank.

<p>Water pump with short pipes at Awdiinle 2</p>	<p>Unclean and unsafe water in the animal trough at Awdiinle 2</p>

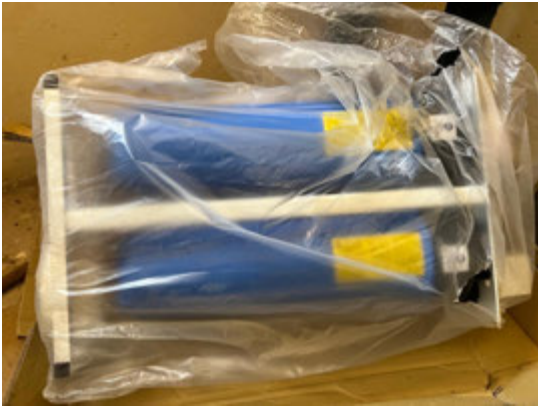
<i>Source: OAGS site visit photo taken on 12th June 2024</i>	<i>Source: OAGS site visit photo taken on 12th June 2024</i>

4.2.6 A water catchment costing **\$128,868.93**, was established at **Wadgelinsoor site in Galmudug State**. However, the site inspection conducted during the audit revealed the issues with the condition of the constructed water point. It was noted that the water flow to the tank was disrupted because the solar pump controller, essential for pumping and transmitting water, was not working as it was damaged. As a result of this damaged controller, the community has been without water for few months, but prior to this issue, the community had been utilizing the water facility. Additionally, although an UV treatment equipment was purchased and delivered to the site to purify the water, it was never installed, hence the community has not benefited from its relevance. This recent situation with the controller has deprived the community of access to clean and safe drinking water and other domestic purposes.

<i>Uninstalled water purification system in the watchman's house at Wadgelinsoor site</i>	<i>Failed solar pump controller in the watchman's house at the Wadgelinsoor site.</i>

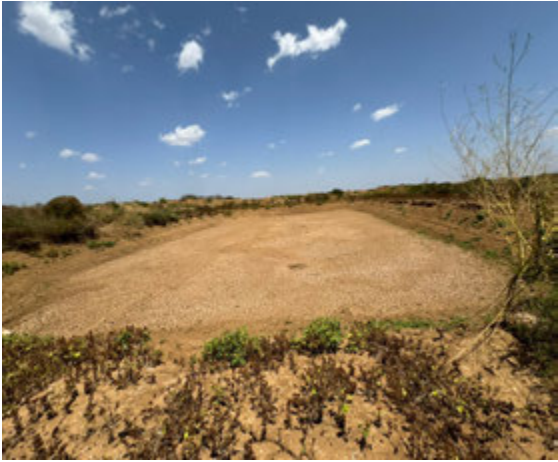
<i>OAGS site visit photo taken on 17 March 2024</i>	<i>OAGS site visit photo taken on 17 March 2024</i>

Throughout the audit, the team noted that dams constructed with plastic sheet liners in **Galmudug State** had better water storage capacity compared to those in **Southwest State**, which were built without liners. It was observed that one of the dams in Southwest State had failed to collect and store water from the rain. This was physically verified and confirmed by community members, who reported that water seeped through the ground of the dam. Additionally, other dams in Southwest State also showed poor water storage capacity. This issue may have resulted from improper planning, where inaccurate conclusions were made that the dams did not need plastic sheet lining without conducting proper assessments.

<i>Constructed dam with storage capacity issue in Southwest State</i>	<i>Wet soil collected from the dam's ground, showing evidence of water seepage</i>

We recommend that the PCU and PIU address the critical issue of water loss through seepage to ensure the long-term sustainability of the constructed dams for community benefit. It is advised to prioritize the use of plastic sheet liners in all future dam constructions to enhance water storage and ensure durability.

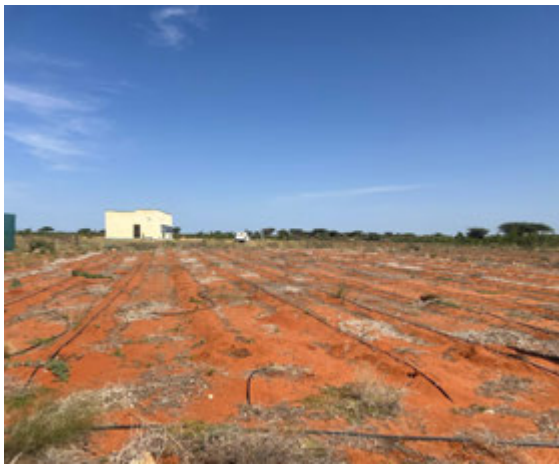
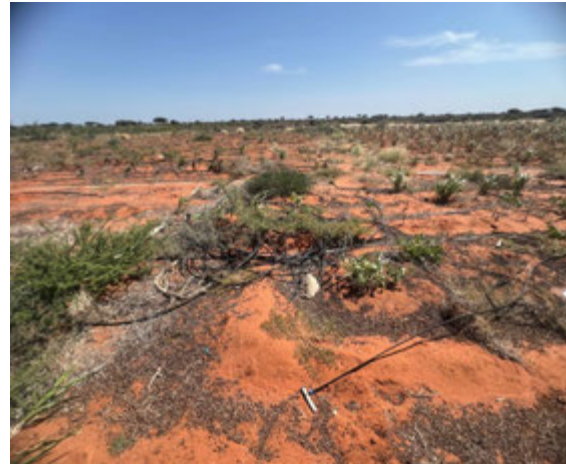
Source: OAGS site visit photo on 13th June 2024

4.5.2 At the Ballihigis site in Galmudug State, agricultural activities with a total cost of **\$127,000** were carried out. However, the audit revealed significant issues with the sustainability of the community garden. The audit team found that crops such as peppers, tomatoes, watermelon, and beans were heavily damaged by pests and appeared to be neglected. Furthermore, the Bill of Quantities (BOQ) specified the planting of palm, coconut, and mango trees, but none of these fruit trees were present

in the garden during the inspection. According to the community, the seeds planted had been harvested only a few times since the farm's establishment. Additionally, as reported by the community insufficient training was provided and the lack of adequate farming technique training for the farmers contributed to poor maintenance and sustainability of the garden.

The community garden observed in Ballihigis

We recommend the PCU and PIU to address the identified shortcomings. It is advised to prioritize strict adherence to project plans, enhance project management and oversight, invest in comprehensive farmer training, and foster strong community engagement for similar future activities.

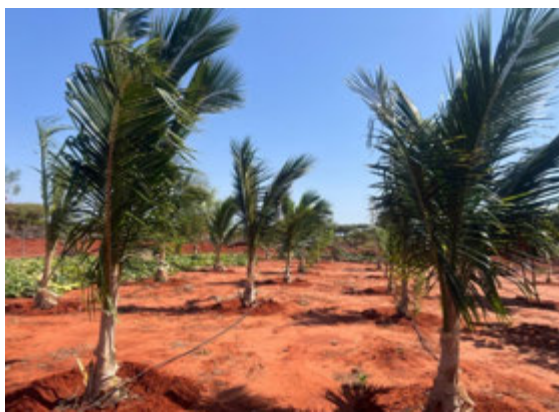
Source: OAGS site visit photo on 14th June 2024

4.5.3 The sum of USD126,471.32 was spent on the agriculture activities implemented at Laanle site in Galmudug State, and during the visit of the audit team observed opportunities for enhancing the sustainability of the garden farm established for the community. Crops such as pumpkin, tomatoes, spinach, and melon were planted, and they were in good condition. The audit also observed the fruit trees planted such as mango, banana, coconut, guava and lemon. As per reported by some members at the garden the community was given enough training, and this has led to the farmers in the community being adequately trained and awareness was raised among the community about their roles and responsibilities towards the garden.

Coconut tree at Laanle site in Galmudug State

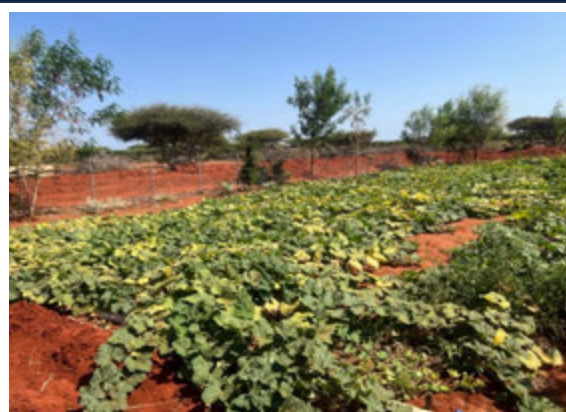
Source: OAGS site visit photo on 14th June 2024

Pumpkin
